FHWA/CA/TL-88/05

June 1988

Office of Transportation Laboratory
California Department of Transportation
Sacramento, California 95819

TENSAR REINFORCED SOIL

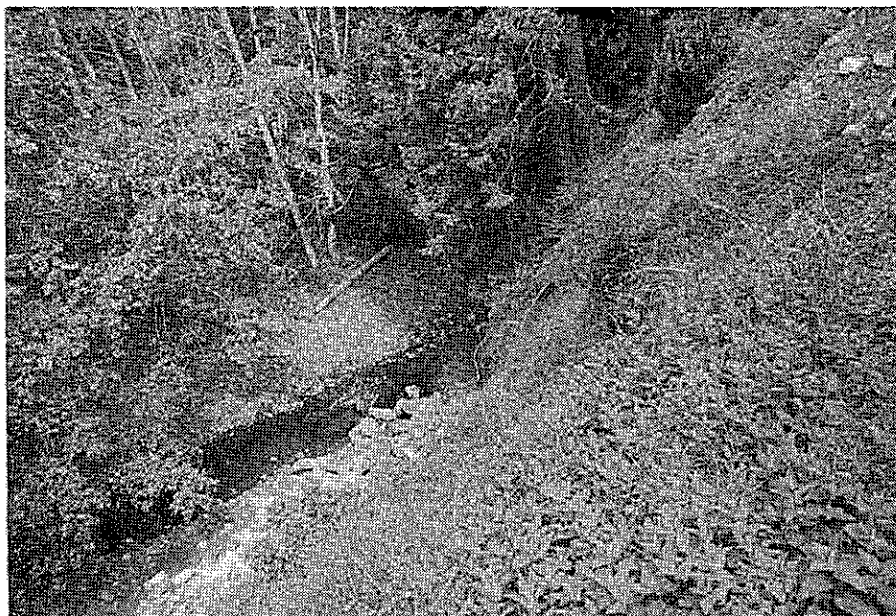
Photograph #01.

Preconstruction site conditions at both embankments are shown in Photographs #01 and #02. Access to both sites was extremely difficult due to the steep terrain. Working room at both sites was severely restricted between the existing slope and La Honda Creek as shown in Photograph #03.

Preconstruction site
conditions, PM 10.05.

Construction access
will be difficult.

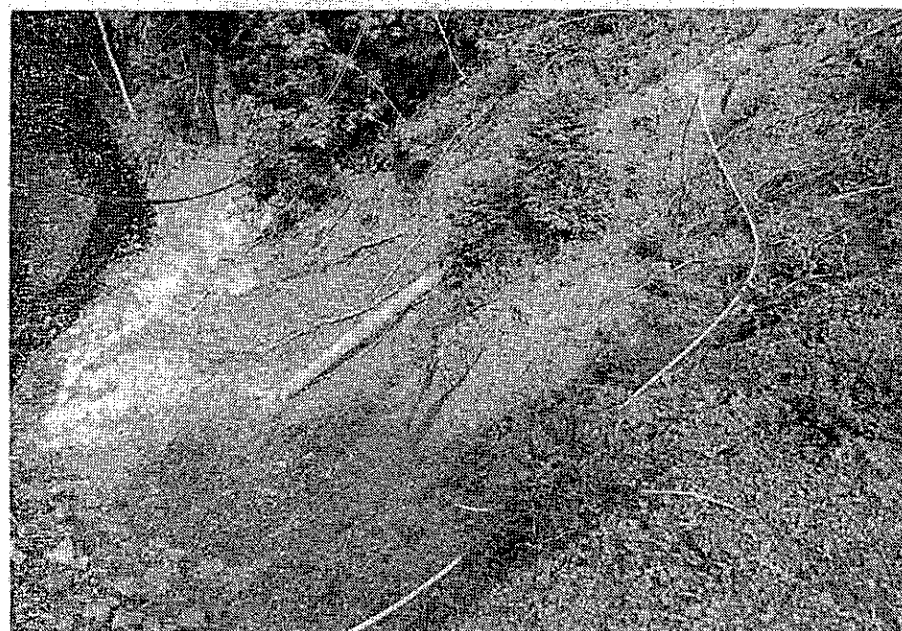
Photograph #02.

Preconstruction site
conditions, PM 9.85.

Construction access
will be difficult.

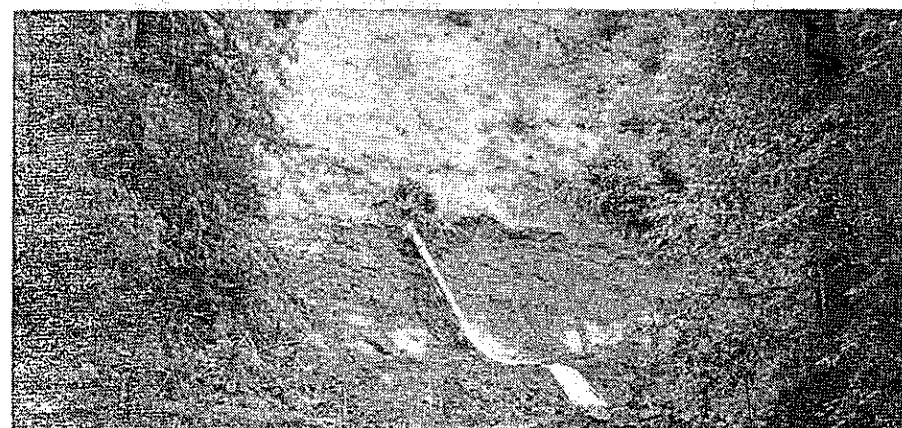
Photograph #03.

Restricted working
room common to both
sites.

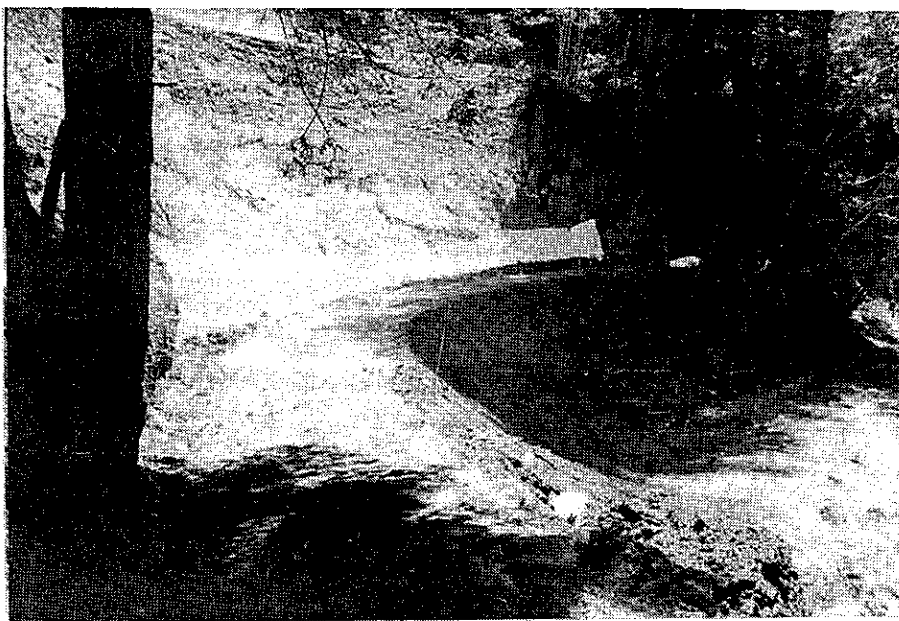
Photograph #04.

The unreinforced section was placed from the foundation to a height of fifteen feet, Photograph #04, and protected from stream erosion by a rock slope. The rock slope, which can be seen in Photographs #08 and #09, was keyed into the original ground to a minimum depth of five feet adjacent to the creek. The Resident Engineer extended the limits of the rock slope protection at both embankments to increase rigidity and stability.

Unreinforced section.

Filter fabric shows
between cut slope and
fill.

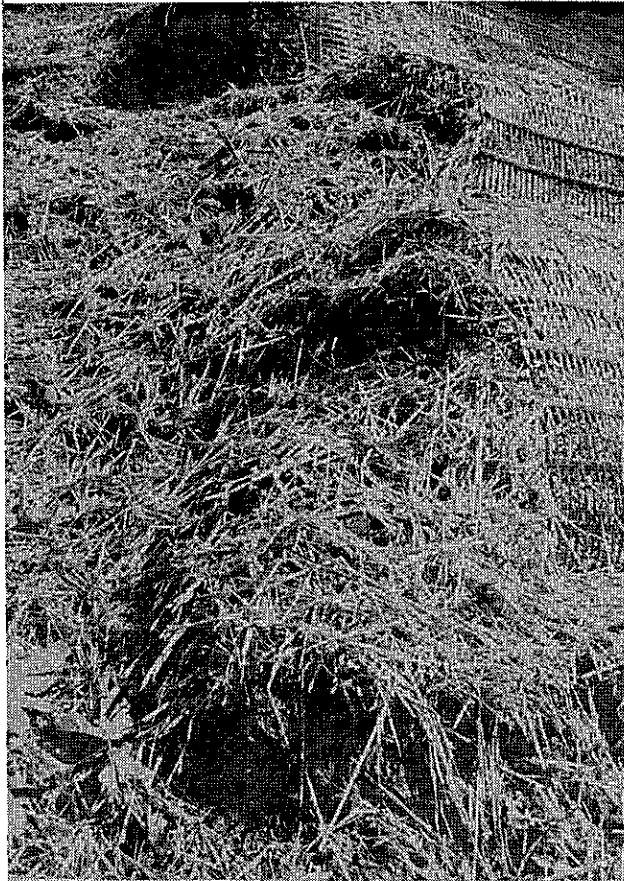
Photograph #10.

End of step.

Untucked end of step.

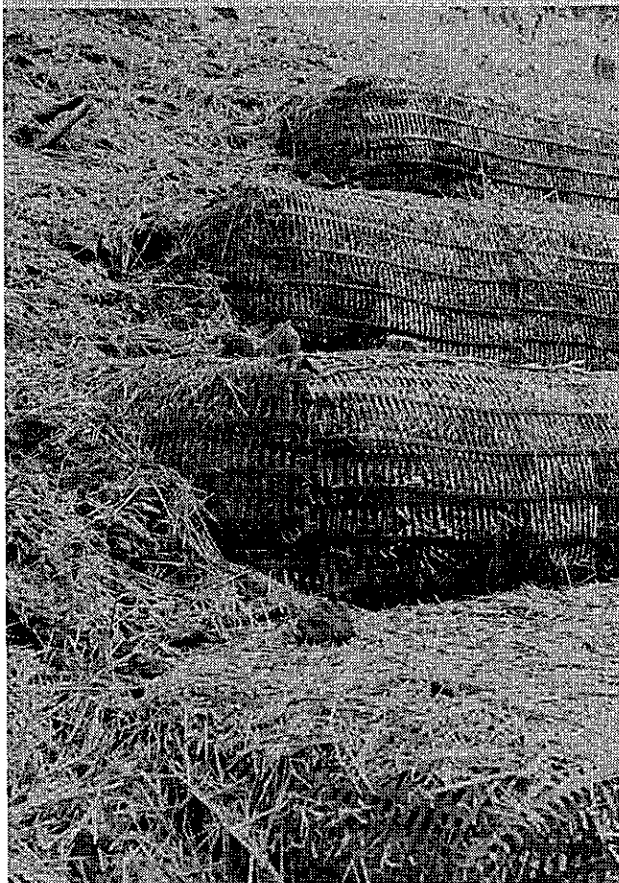
Photograph #11.

End of step.

End of step tucked
into original
ground.

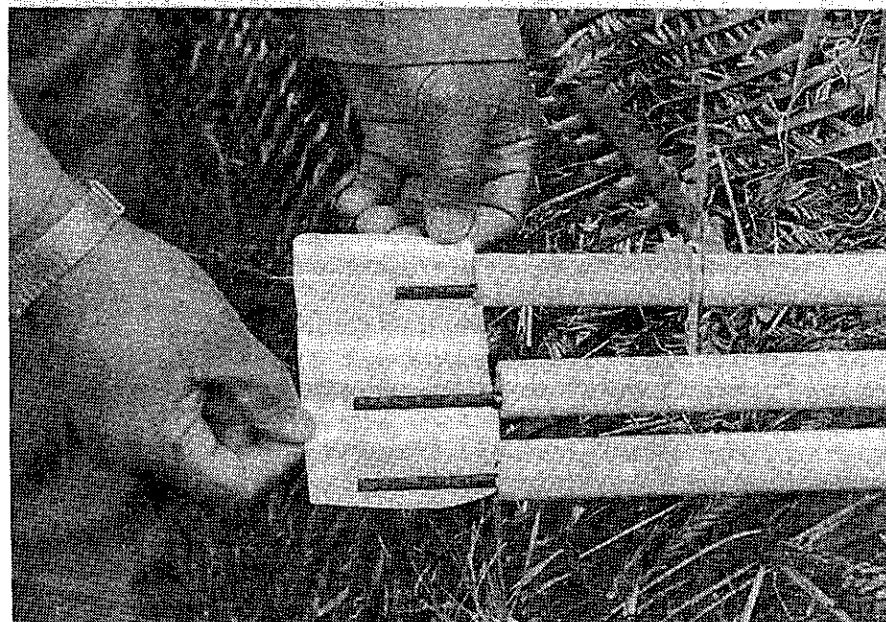
Photograph #17.

Extensometer
installation.

Outward movement of
rod ends, past end of
anchor rod, reflects
movement of geogrid
and the fill.

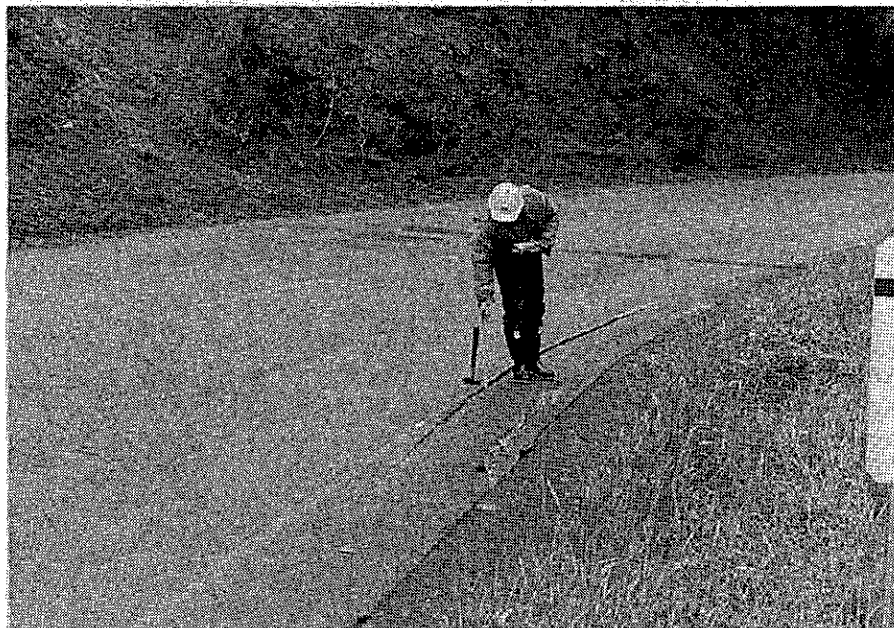
Photograph #19.

Immediately after construction the pavement cracked at both embankments as shown in Photographs #19 and #20. The cracking was controlled by minor patching and did not

Pavement cracking.

Minor pavement
cracking due to
settlement.

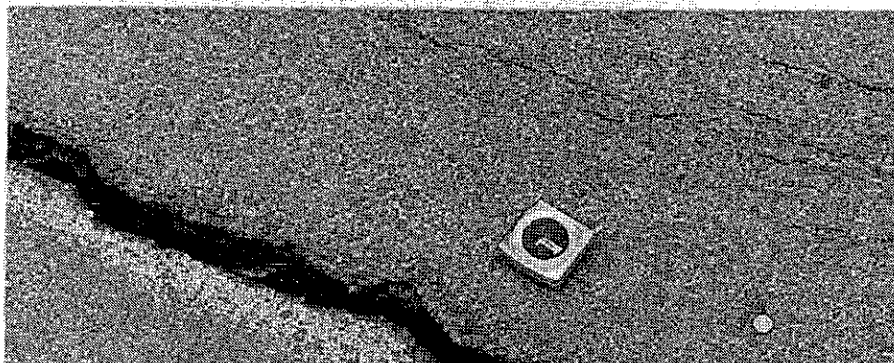
Photograph #20.

Pavement cracking.

Close-up of pavement

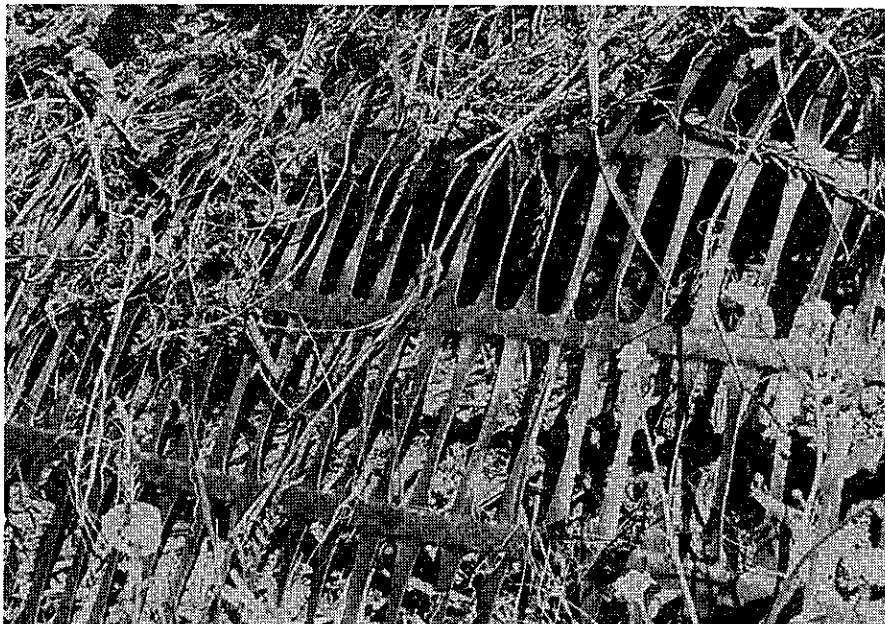
Photograph #21.

The straw has decayed, leaving voids behind and under the geogrid and the surface of the embankment is slowly changing from "step-like" to a more or less continuous slope, Photographs #21 thru #23. Moving about on the steps of the slope is becoming increasingly difficult and staff should be cautious when doing so.

It appears that more than 3 inches of straw was used in some places. The straw has now decayed, allowing voids to form under the geogrid. This leaves the geogrid unsupported and in some places the geogrid has deformed to approach a more natural slope. In other places, the geogrid is unsupported by any underlying materials. Both of these conditions make walking on the embankment difficult. Straw used in future projects should be kept to ~3 inches.

Present condition.

Void under geogrid
left by decayed
straw.

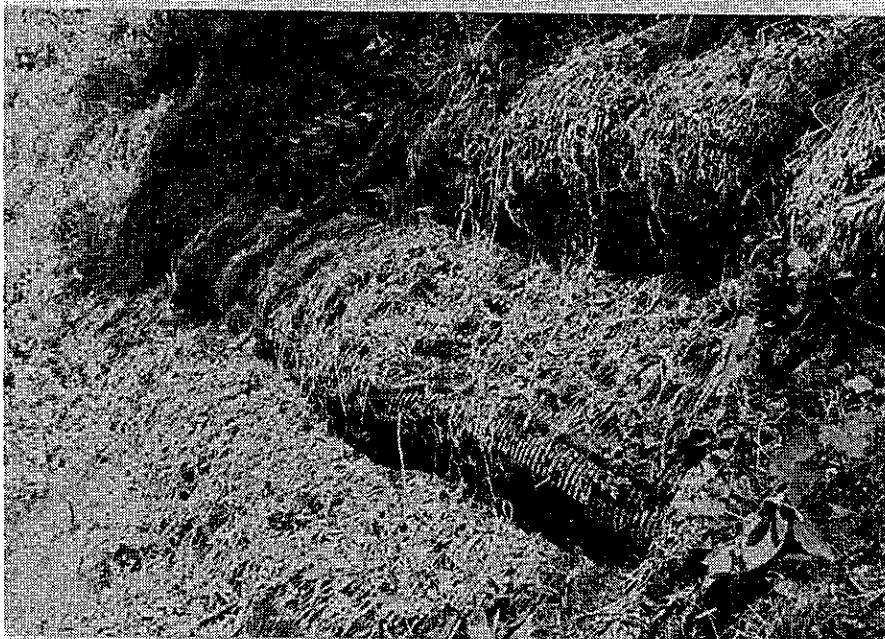
Photograph #22.

Present condition.

Deformation from
stepped surface to
a more continuous
surface.

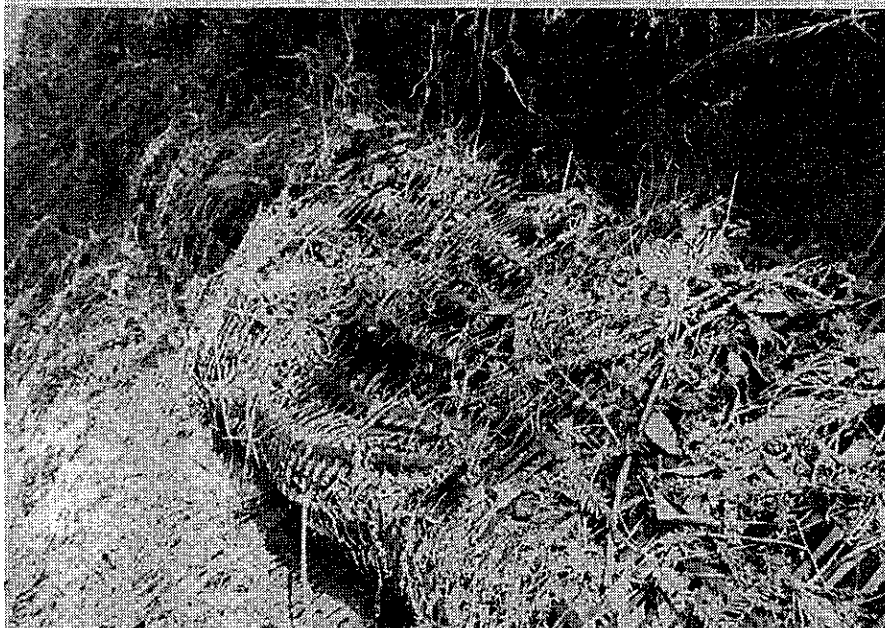
Photograph #23.

Present condition.
